# **INFORMATION HANDOUT**

**For Contract No. 04-1SS464  
On Route 680  
At Monument Boulevard  
In Pleasant Hill in Contra Costa County**

Subject : Foundation Recommendation for Roadway Settlement –Geotechnical Design Report

Subject: MAINLINE PAVEMENT REPAIR RECOMMENDATIONS FOR PS&E

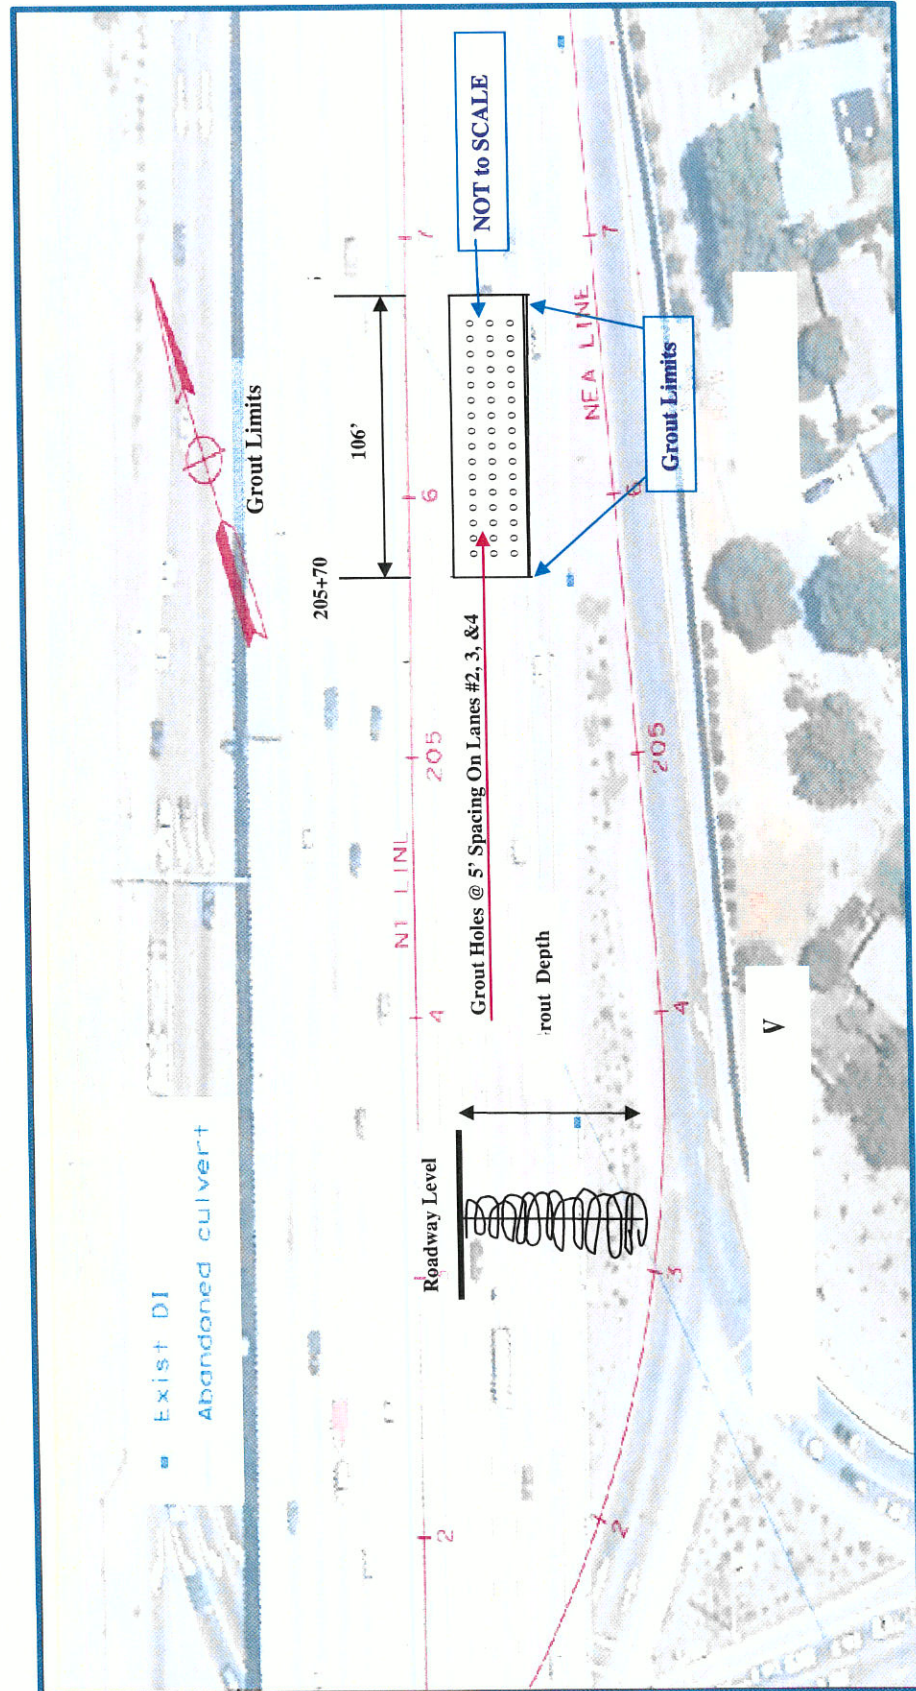
**EXHIBIT A**

This is in response to your memorandum dated October 18, 2012 requesting our foundation recommendation for northbound Route 680 roadway settlement. The settlement is located on northbound Route 680, approximately 500 ft north of Monument Boulevard Undercrossing in the City of Pleasant Hill in Contra Costa County. See attached Exhibit A for all the details.

- The settlement area is about 106 ft (between stations 205+70± and 206+76±) long and about 48 ft wide.
- The localized PCC pavement settlement area covers Lanes #2, #3, and #4. Most of the cracks within the settled area are located between Lanes # 2 and #3.
- The settlement area and its associated cracks appear to becoming worse since we visited the site on October 2012 and causing a big depression in the roadway.

- The existing drainage system (System 28) most probably is the main cause of the settlement. The roadway settlement area is directly above this system and the embankment material is soft with high moisture content to the depth of about 25 below roadway surface (location of the culvert). As mentioned above, the culvert may have not been abandoned properly, so loss of embankment fines through the culvert joints is highly possible. Due to the weight of additional fill over the existing culvert, the culvert may have collapsed.
- Poor compaction could be another reason for the settlement. In this scenario, lack of compaction has led in cracking the pavement PCC slabs allowing significant amount of surface runoffs to penetrate into the ground softening the embankment materials. This is evident from the relatively high moisture content of the soil samples retrieved from the borings.

Regardless of the cause of the PCC settlements mentioned above, in order to mitigate settlement at this location, we recommend cement compaction grouting beneath Lanes #2, #3, and #4 (Station 205+70± to 206+76±) to the depth of maximum 25 ft below roadway surface. Refer to the attached Exhibit A for details.

The estimated quantity of cement grout required is about 4800 ft<sup>3</sup> (total of 176 grout holes).

Injecting grout will create an uneven pavement surfacing. After completion of the grouting, we recommend replacing the PCC slabs at the location of the settled and cracked areas.
